# Fertilizer Tank Relining

Ar-Tech Coating Ltd.

October 2015

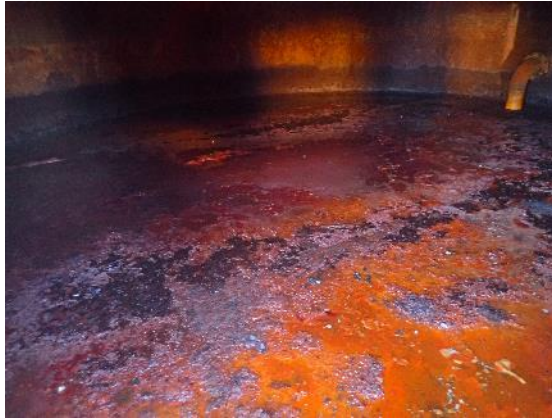
Tank prior to cleaning. Solids build up on the floor.

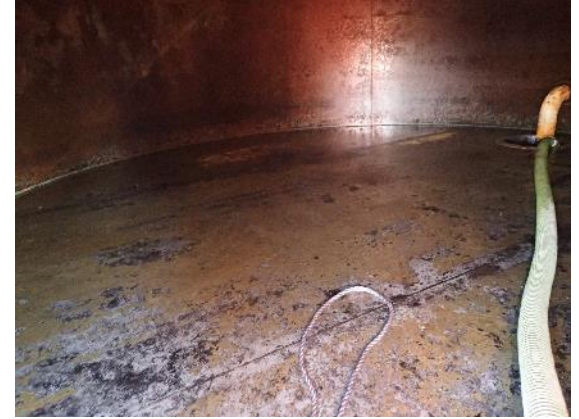
Tank cleaned and ready for blast. Some pitting on the tank floor and bottom ring.
